# Manhole Inspection Summary

Manhole # S25M\_\_028MH

**Location** Address: **S.CAREY ST.**

Cross Street: **HERKIMER ST.**

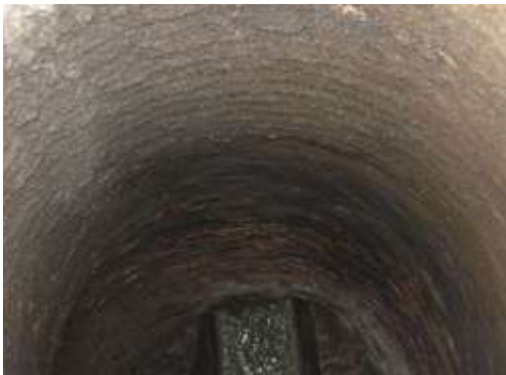
Additional Defect 2

MUD ON CORBEL WALL AND  
INFILTRATION IN BARREL

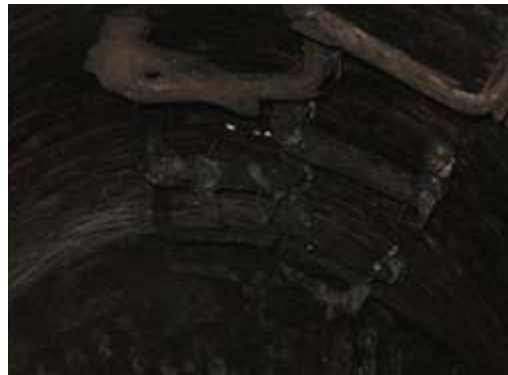
Additional Defect

EVIDENCE OF SURCHARGE ON  
STEPS

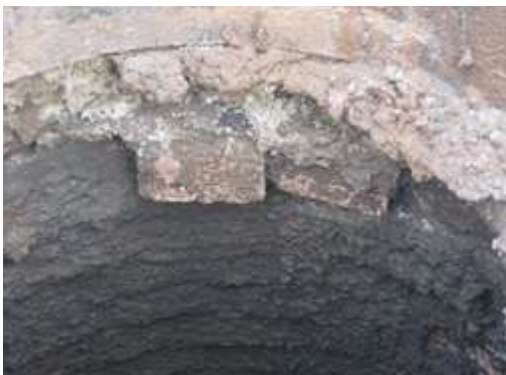
Defect 7

EVIDENCE OF INFILTRATION MUD AT  
THE CHIMNEY AND CORBEL MISSING  
MORTAR

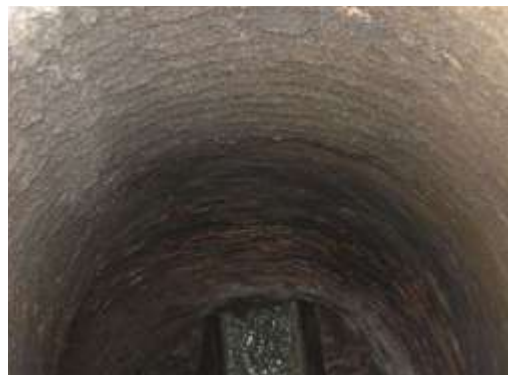
Defect 6

MUD ON CORBEL WALL AND  
INFILTRATION IN BARREL

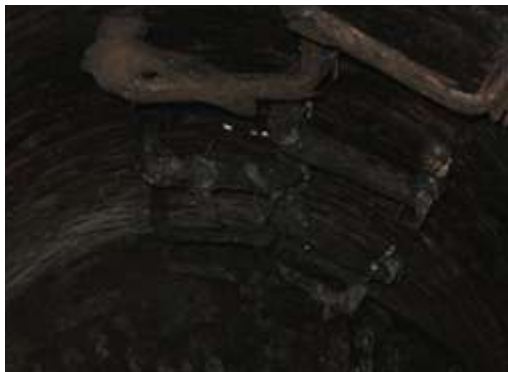
Defect 2

EVIDENCE OF SURCHARGE ON STEPS

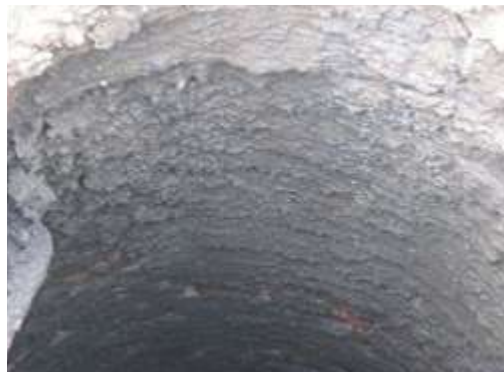
Defect 5

CORBEL WALL COVERED WITH MUD/EVIDENCE OF INFILTRATION

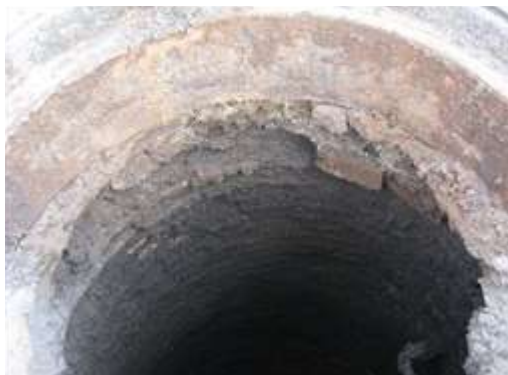
Defect 4

EVIDENCE OF INFILTRATION AT CHIMNEY TO CORBEL MUD DEPOSITS, Chimney has loose bricks,

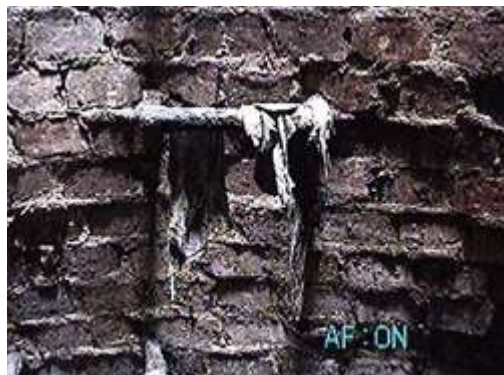
Defect 3

DETERIORATED CORBEL WITH EVIDENCE OF SURCHARGE ON STEPS

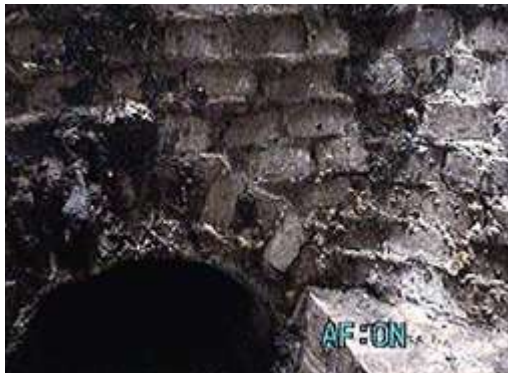
Defect 1

DETERIORATED BARREL

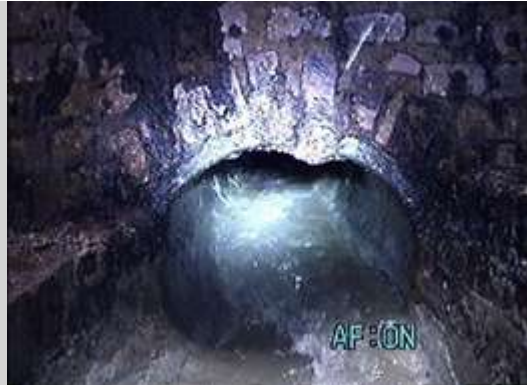
12 O'Clock Outflow

18 in. Circular Gravity Sewer  
Pipe Out @ 12 O'Clock

Pipe Height: **18** (in.) Rod and Bar (Angled)  
Pipe Material: **Clay** ☐ Pipe Lined  
Invert Depth: **15.90** (ft.) Flow Characteristics: **Turbulent**  
Deposits: ☒ None ☐ Mud ☐ Sludge ☐ Debris ☐ Grease  
Silt Depth: **0** (in.) Deposits Extent:  
Infiltration: **Evidence** Pipe Seal Cond: **Unknown**

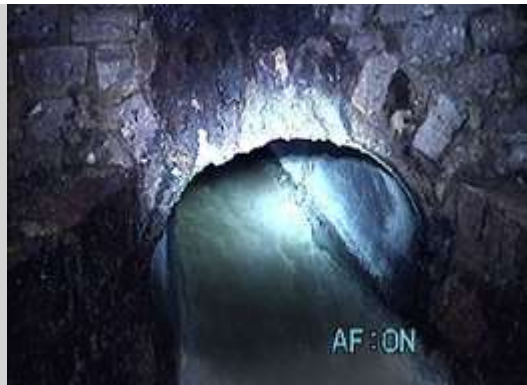
5 O'Clock Inflow

18 in. Circular Gravity Sewer  
Pipe In @ 5 O'Clock

Pipe Height: **18** (in.) Rod and Bar (Angled)  
Pipe Material: **Clay** ☐ Pipe Lined  
Invert Depth: **15.90** (ft.) Flow Characteristics: **Turbulent**  
Deposits: ☒ None ☐ Mud ☐ Sludge ☐ Debris ☐ Grease  
Silt Depth: **0** (in.) Deposits Extent:  
Infiltration: **Evidence** Pipe Seal Cond: **Unknown**
